Subject: **3M™ Protecta® Cabloc™ Traveller damage assessment**

Region:	<b>EMEA</b>	Language:	<b>EN</b>	Number:	<b>PB0031</b>	Revision:	<b>01</b>
Total Pages:	1	First Issue:	<b>17/08/2022</b>	Rev. Date:	<b>17/08/2022</b>

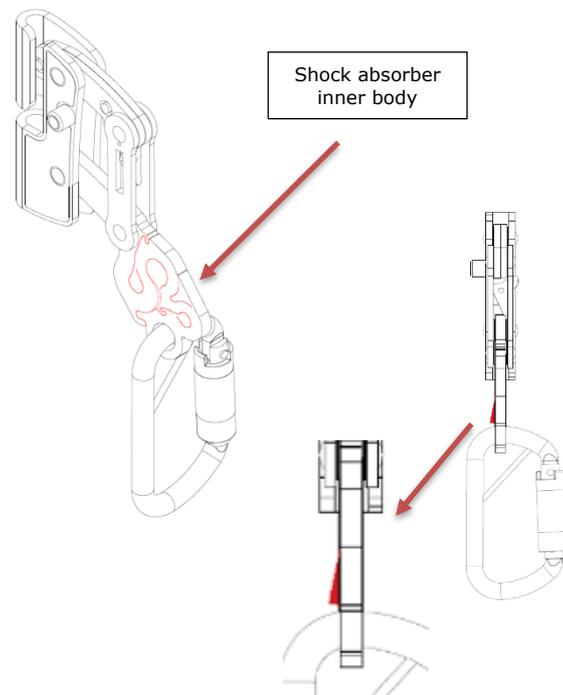
- It has been reported that the shock absorber inner body of the system related travelers (6180200/6180201) can be deformed in specific conditions outside its normal use.

- If the deformation is equal or less than 50% of the overall thickness of the shock absorber body, we accept it's within the allowable deformation margin, and the advice is to leave it and DO NOT push it back to the original form.
- For deformations of more than 50% please suspend the use of the traveler and get in touch through your local representative or contact our customer services.
